# cpc AR/HR Z Series Lubrication Storage Pad Testing Report

## AR15 Lubrication Storage Pad Testing Data

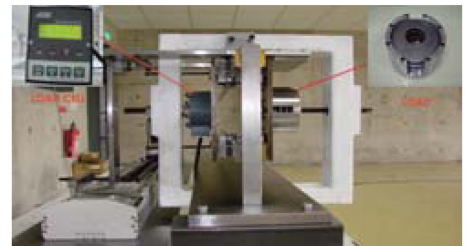
## ■ Testing equipment

Tested products: AR15 blocks with lubrication storage pads, 8 pieces, and AR15 rails, N accuracy grade, 1500mm Length, 4 pieces

Testing condition	
Rating load capacities(each Block)	1.8KN(C=9KN · C0=17.5KN)
Stroke	0.96m
Max running speed	1m/s
Lubricant	DAPHNE SUPER MULTI 68 (Viscosity64.32 CST 40OC)
Lubrication period	No lubrication added during testing period

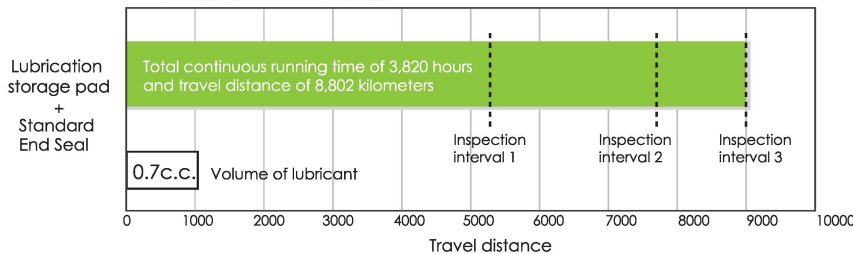
## ■ Testing result

Dried lubricant residue started appearing on rail profile, PU pads, and ball retainer of the tested blocks

Total continuous running time of 3820 hours and travel distance of 8802 kilometers.

Out of eight test blocks, dried lubricant residue appeared on 2 blocks and 1 rail. Dried lubricant residue is indicative of a need for re-lubrication.

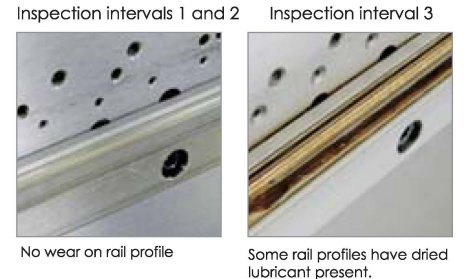
## ■ Test results at inspection intervals

### Inspection intervals 1 and 2: Lubrication Maintained

- Upward lubrication storage pads in good condition.
- Lubricant supply in good condition.
- No wear on the running profile of the rail.

- Downward lubrication storage pads in good condition.
- Lubricant supply in good condition.
